Intel[®] Xeon[®] Processor E5 Family

Specification Update

July 2014

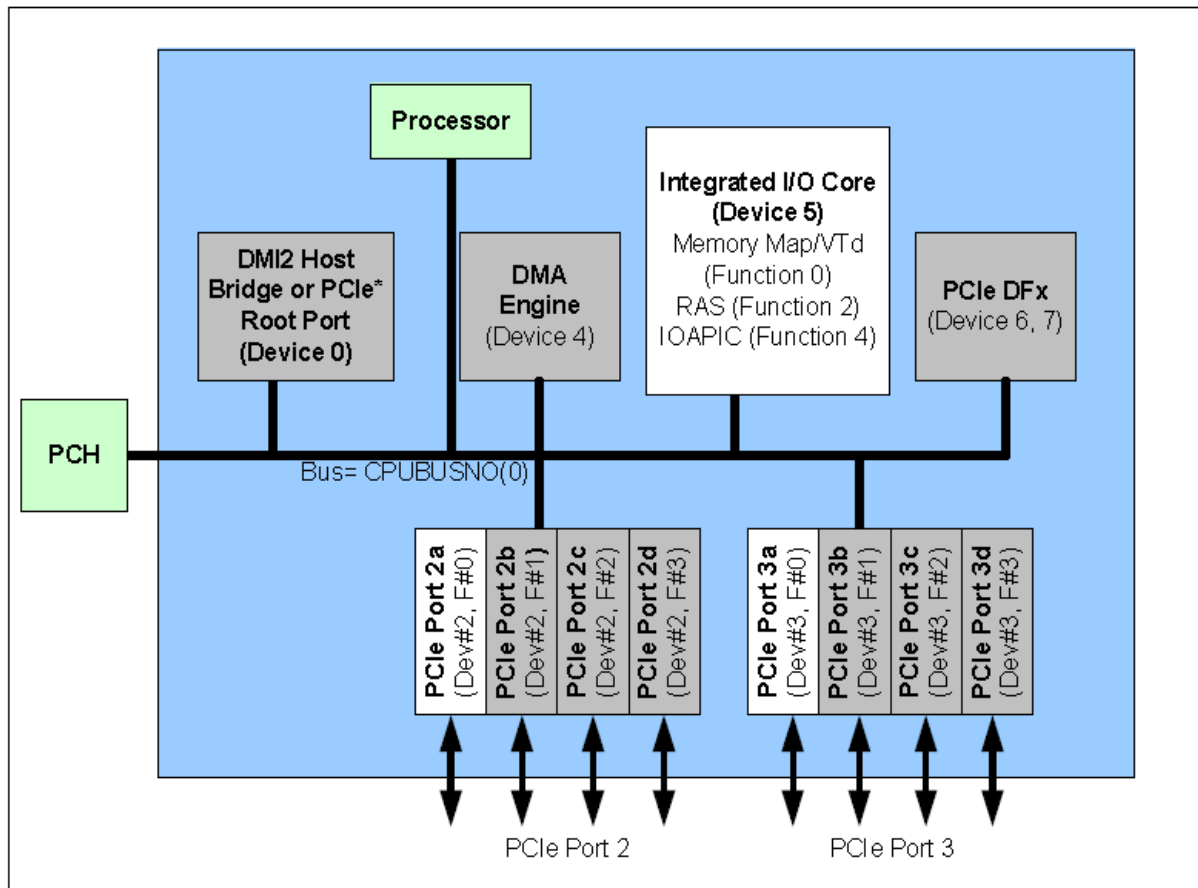
The drawing in the current EDS Volume 2 does not include devices 6 and 7. These are internal devices not generally accessible on production systems. The drawing below is correct.

Device 6, 7: PCI Express Dfx. Contains the PCI Express debug (DFx), Lock, Error Inject Registers.
