# **Intel® Ethernet Controller I210**

**Specification Update**

***December 2016***

Revision 2.1  
332763-005

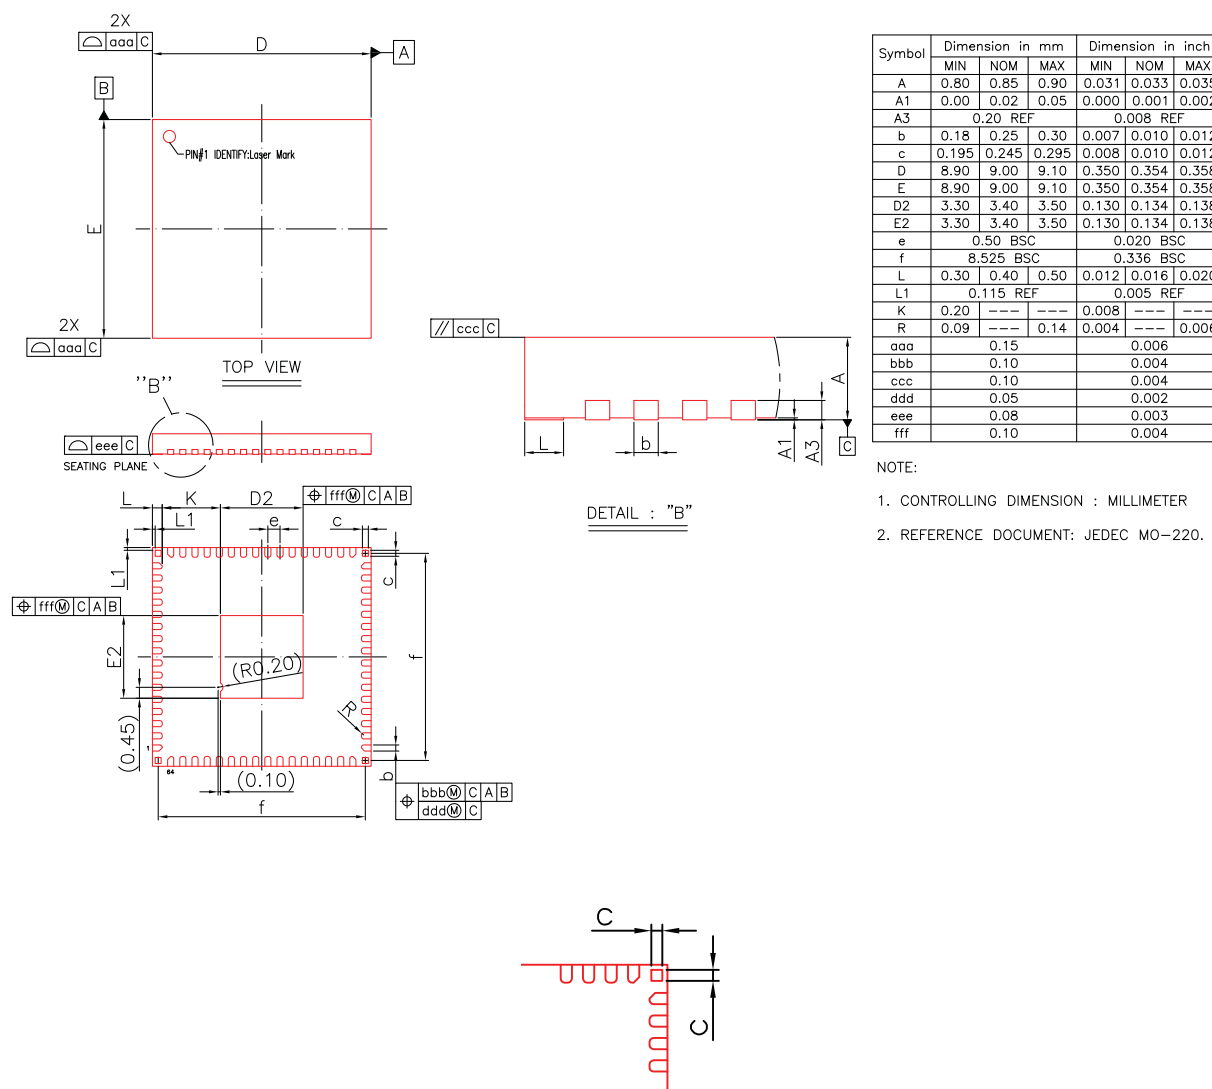
## 7. WGI210CS Automotive Industrial Temperature Fiber Schematic

**Note:** The I210 CS has four no-connect corner pads for added solder joint reliability (as shown in Detail C).
