Desktop 3rd Generation Intel[®] Core[™] Processor Family

Specification Update

June 2014

Revision 018

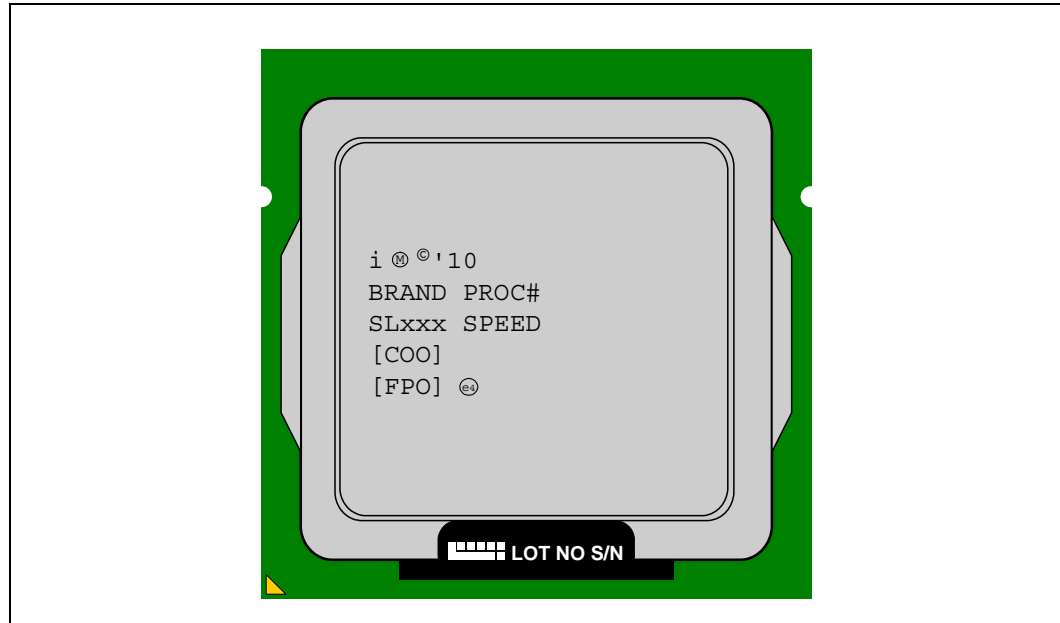
Figure 1. Processor Production Top-side Markings (Example)

The processor stepping can be identified by the following component markings.
