Intel® Atom™ Processor Z3600 and Z3700 Series

Specification Update

May 2014

Revision 004

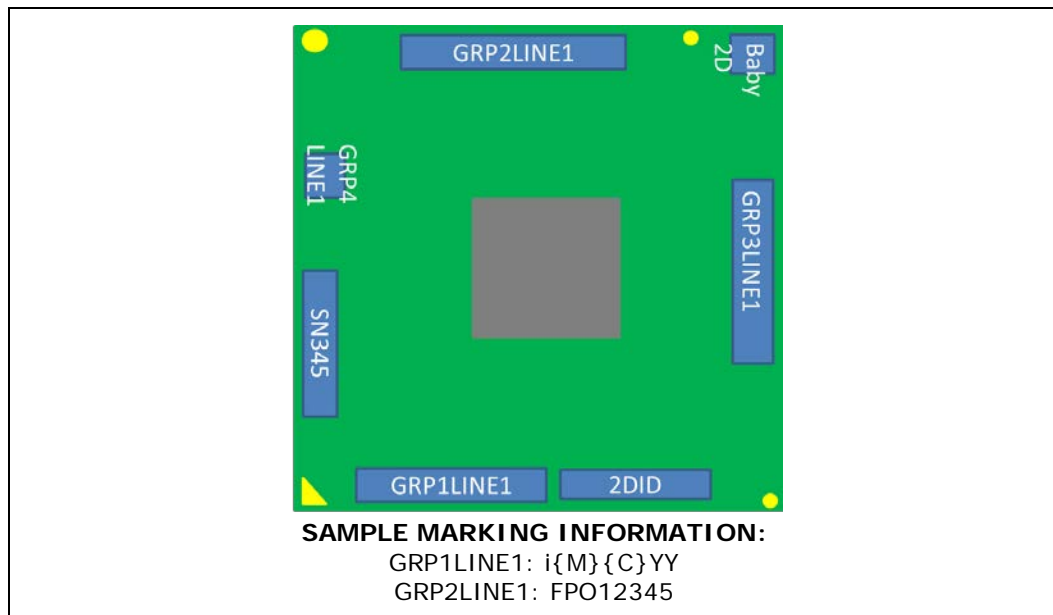
Figure 1. Intel® Atom™ Processor Z3600 And Z3700 Component Marking Information

Processor shipments can be identified by the following component markings and example pictures.
